Measure J would fund needed SRD facility repairs

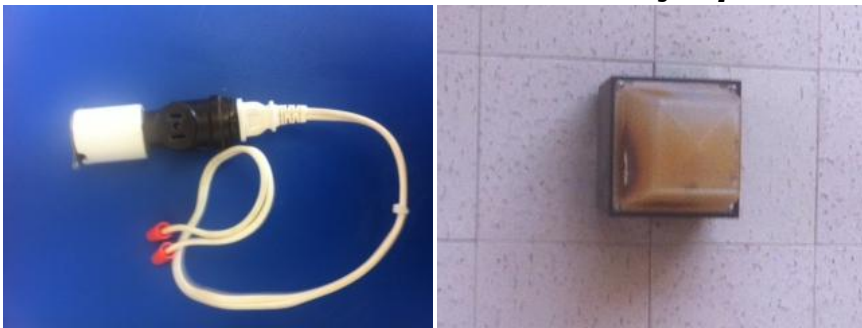
Existing lighting in the SRD Main Building: Considered an “energy upgrade” by former staff

- Incandescent bulb fitting, inserted plug adapter, plug and wire connected to a new florescent fixture. Not to code or grounded. A full electric upgrade is an urgent need.
- Gym light fixtures where previous staff installed incompatible bulbs into fixtures

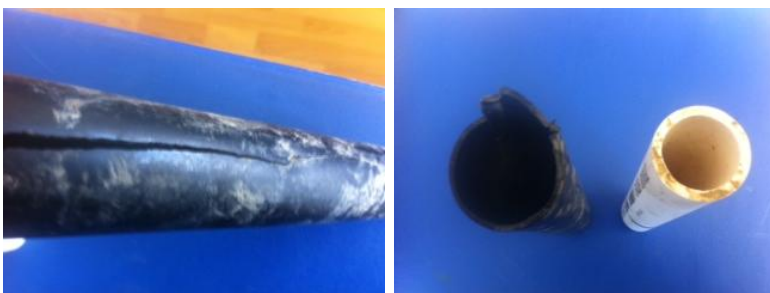
Existing field irrigation:

- Drip system irrigation tubing (black) was used on the main athletic fields instead of code 40 PVC (white). The tube cracks and breaks regularly, creating large mounds of water under the turf. This is expensive to repair in stages.
- Irrigation valves have also been buried throughout the field 12’-18” deep. Standard practice is to place valve controls near the irrigation control station above ground and all in one location for access.
- The rest of the site irrigation been shut off due to similar issues.
